1. Project Name: Kahului DDH
2. Date of Inspection: May 13, 2005
3. Inspection Personnel:

O & M INSPECTION REPORT FOR NAVIGATION PROJECTS

Honolulu Engineer District

KAHULUI HARBOR, MAUI, HAWAII

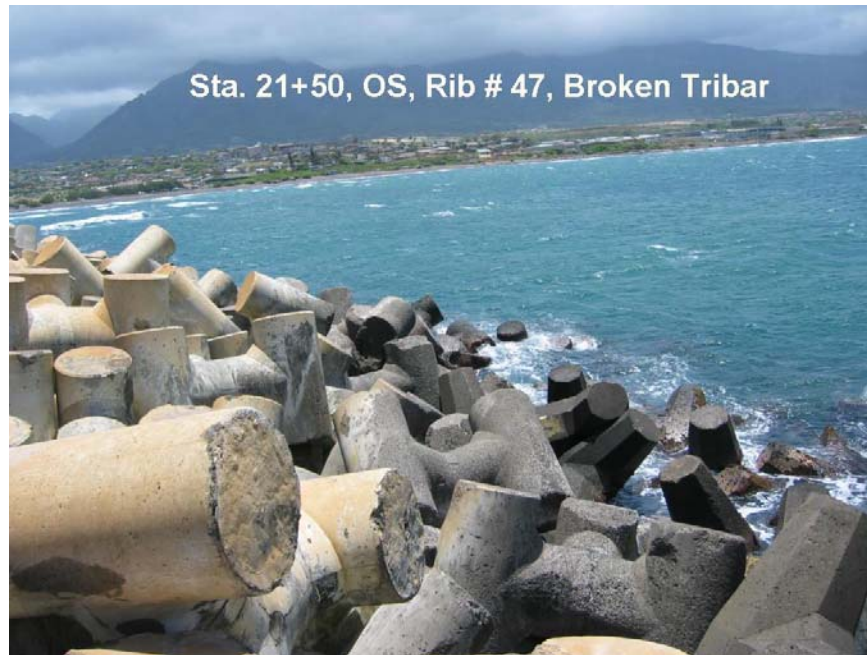
s. Sta. 21+50, OS, (Rib 7), Broken Tribars on sideslope.

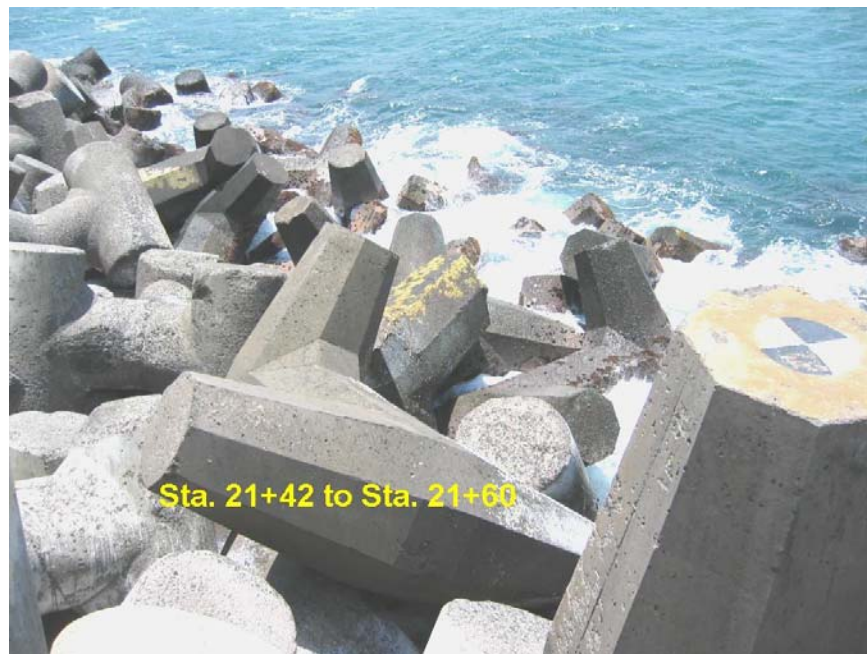
t. Sta. 21+42 to 21+60, OS, 4 broken dolos/tribars.

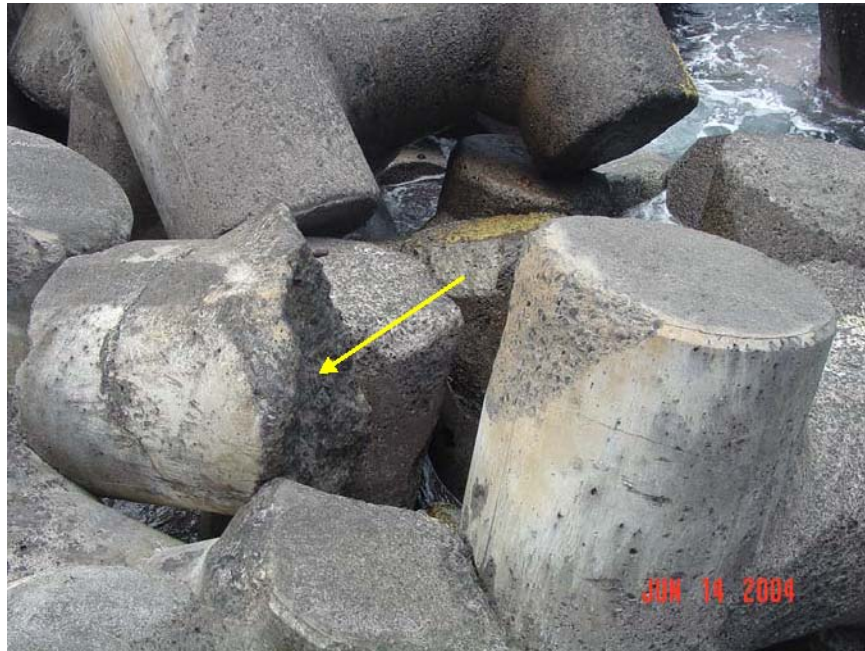
u. Sta. 21+42 to 21+60, OS, 4 broken dolos/tribars.

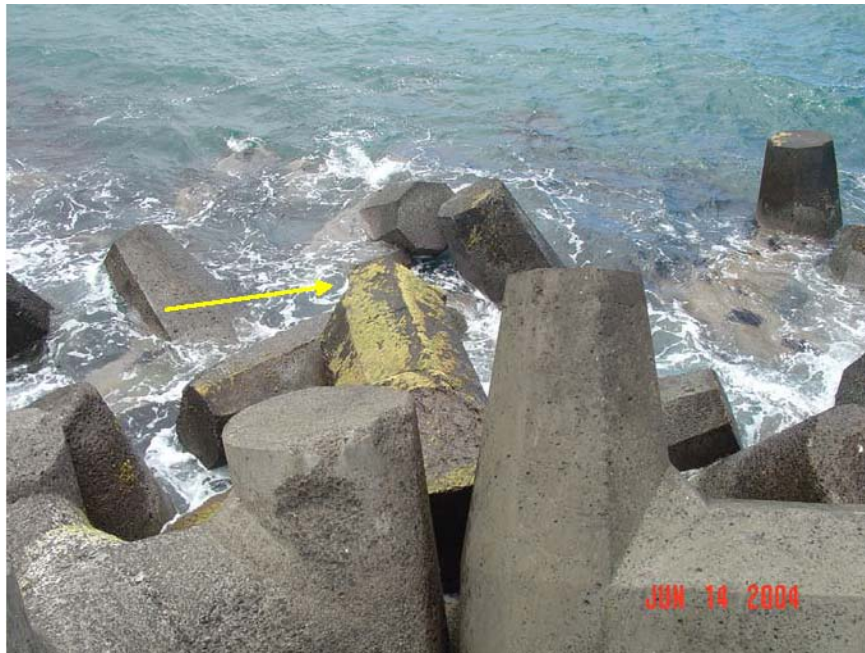
v. Sta. 21+42 to 21+60, OS, 4 broken dolos/tribars.

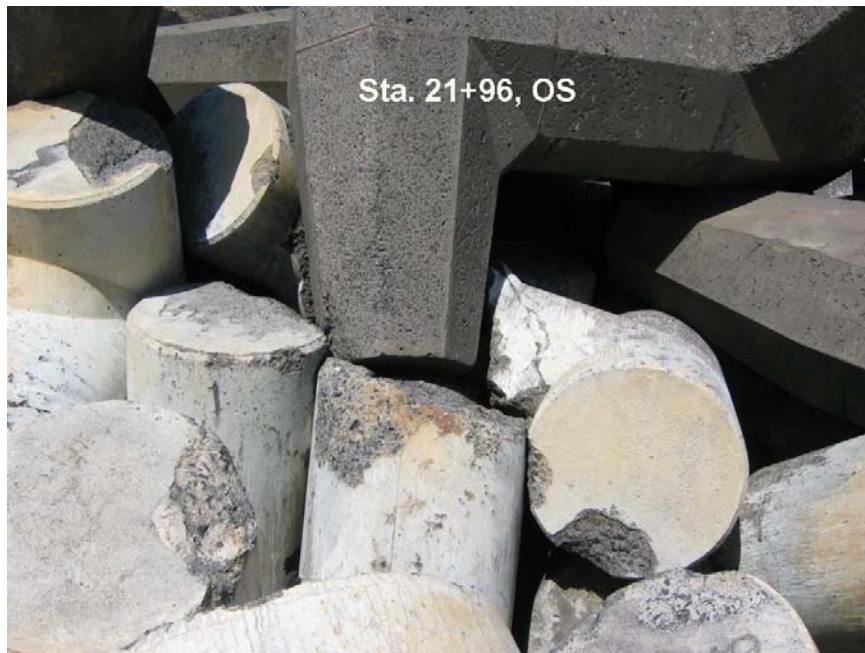
z. Sta. 21+96, OS, Broken tribar.

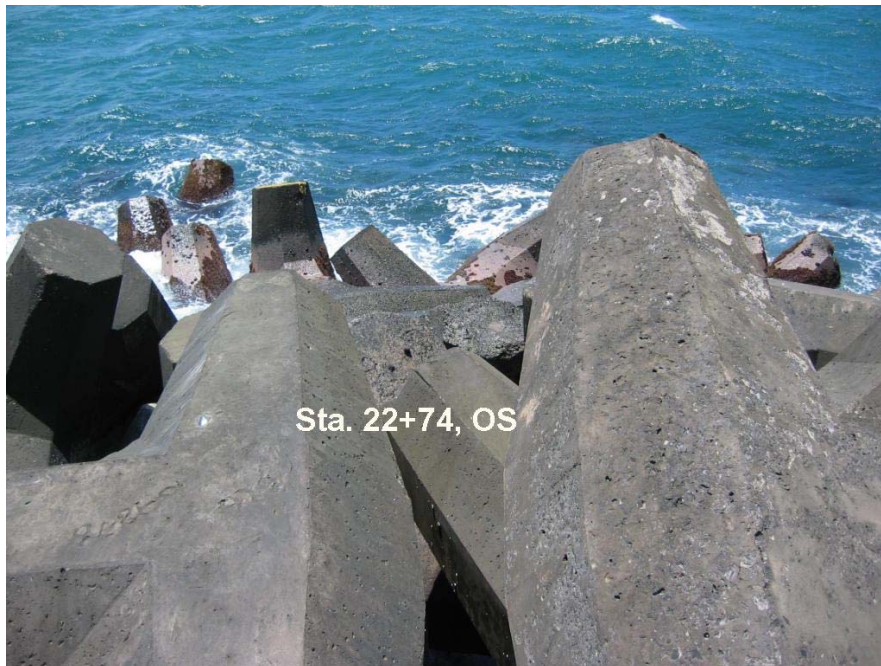
aa. Sta. 22+74, OS, Broken dolo, shank-fluke break.

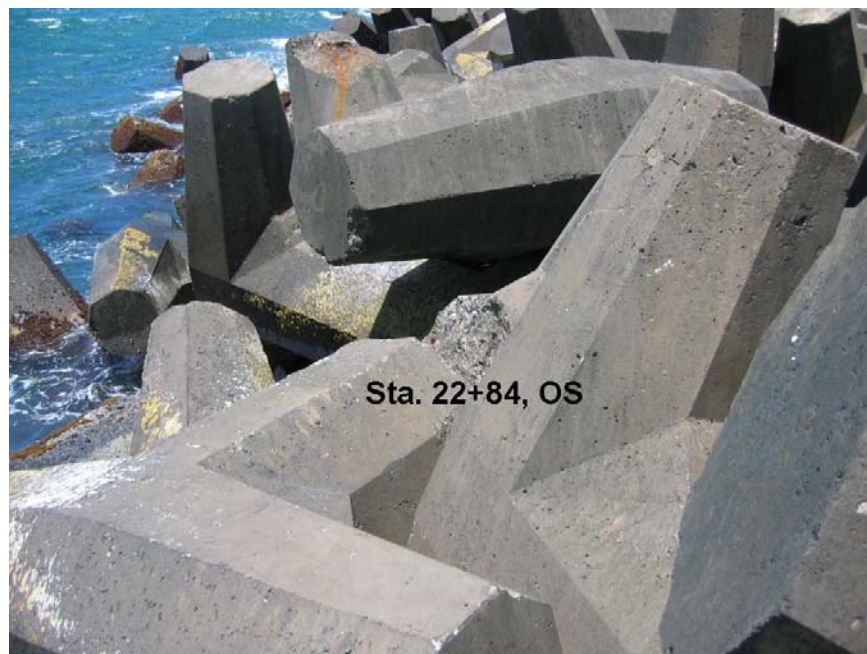
bb . Sta. 22+84, OS, Broken dolo, shank-fluke break.

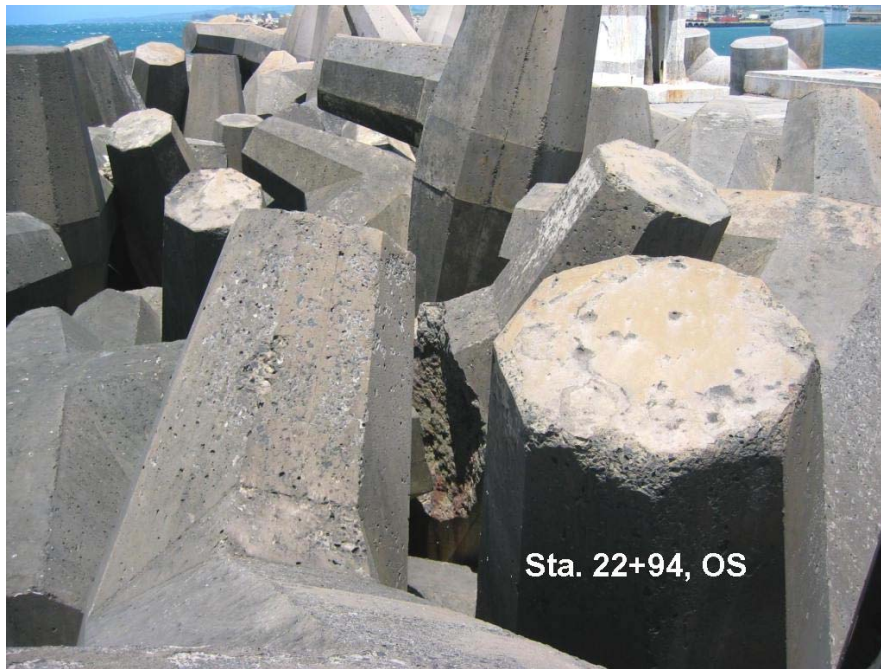
cc. Sta. 22+94, OS, Broken dolo, shank break.

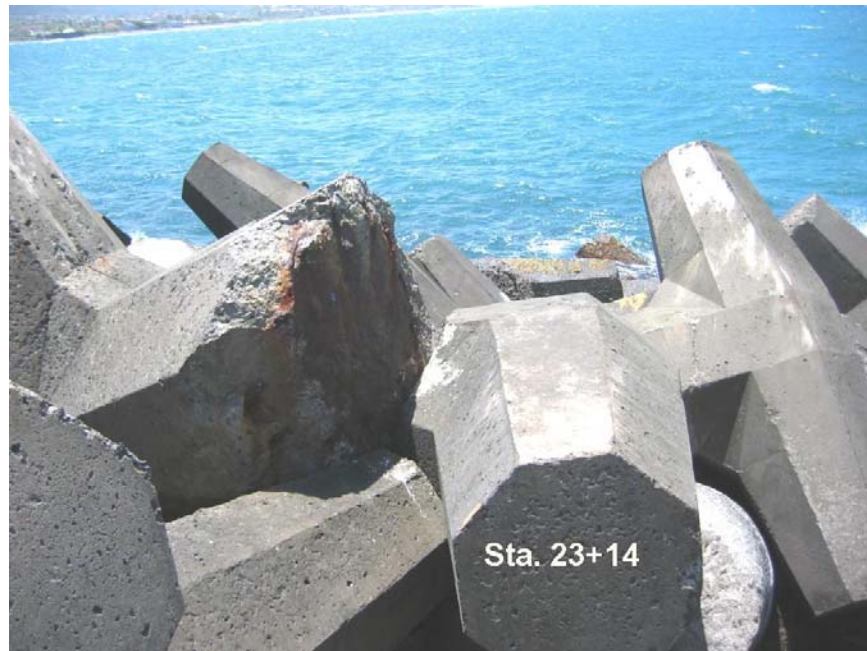
dd. Sta. 23+14, OS, 3 shank breaks.

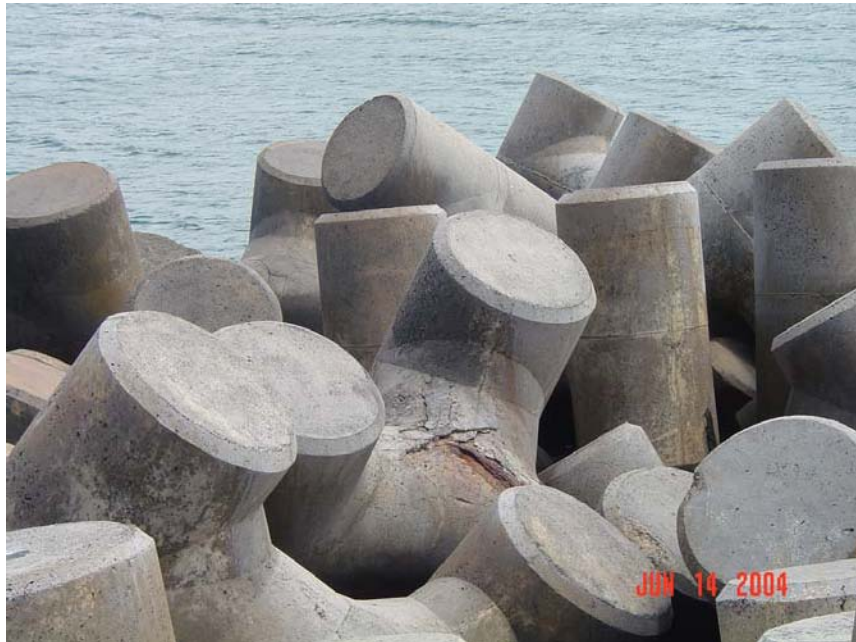
kk. Head, Tribar rusted at center.
